PIC16F630/676 Rev. A Silicon/Data Sheet Errata

The PIC16F630/676 parts you have received conform functionally to the Device Data Sheet (DS40039E), except for the anomalies described below.

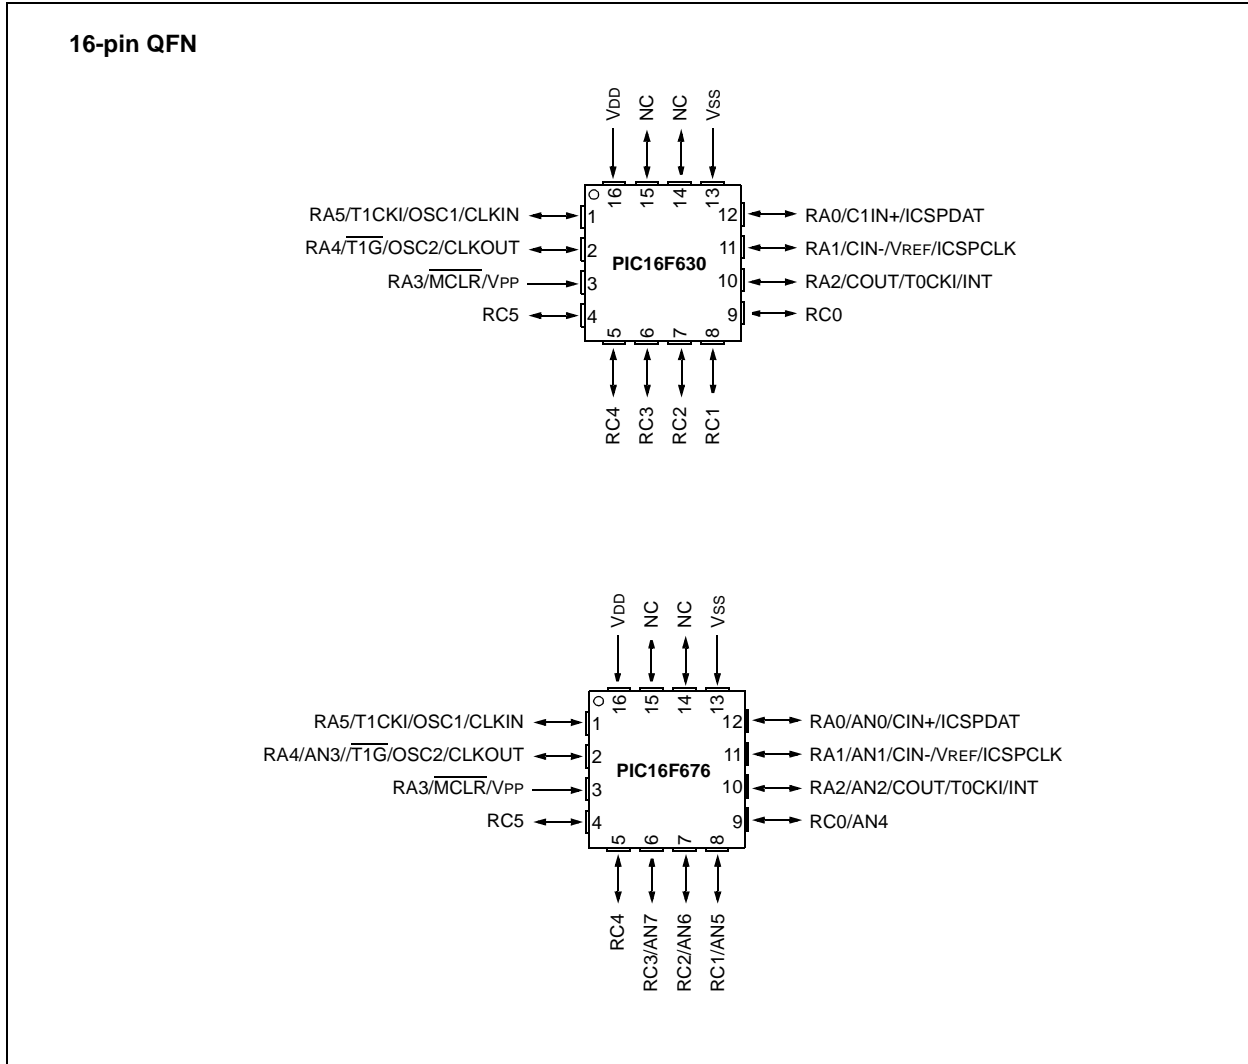
Pin Diagram

4. Module: New 4x4 QFN Package Added

The new 16-pin 4x4 QFN pinout diagrams will be added to the Pin Diagrams figure on page 2 and the Packaging Information chapter as shown below:
